1. Project Name: Kawaihae Deep Draft Harbor
2. Date of Inspection: May 3, 2005
3. Inspection Personnel:

KAWAIHAE DEEP DRAFT HARBOR, HAWAII

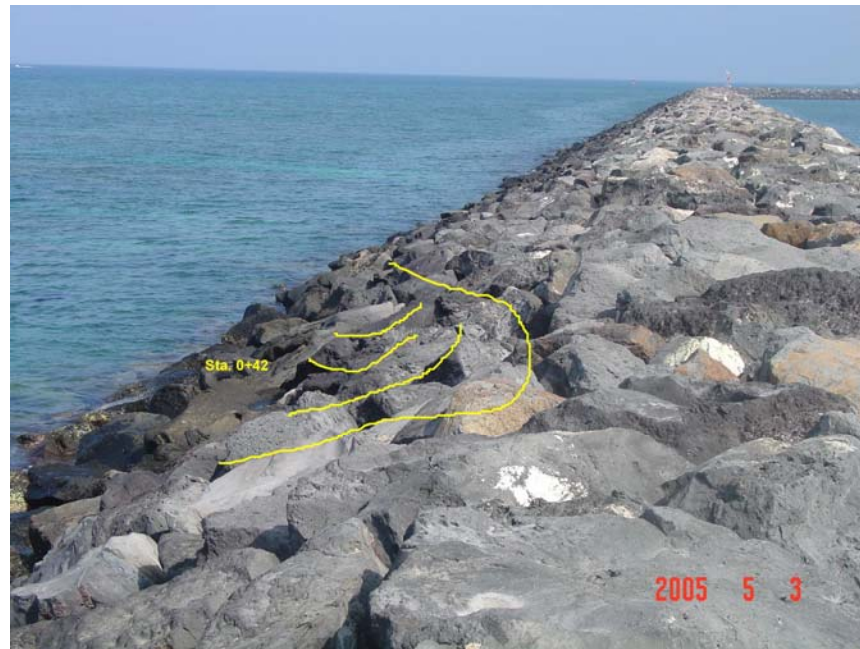
- a. Sta. 0+42 to Sta. 1+07, OS, slight depression on the sideslope, no obvious signs of sliding, monitor.

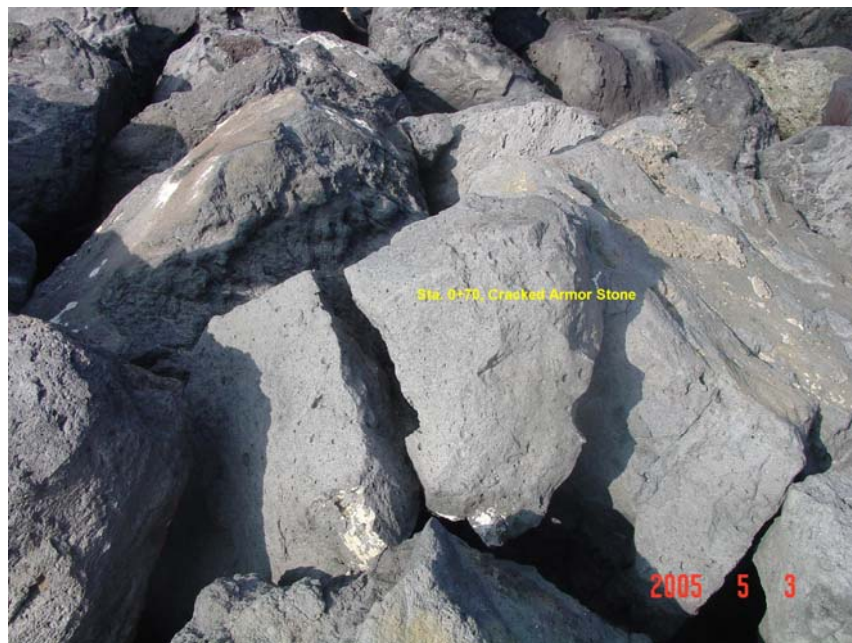
- b. Sta. 0+70, OS, cracked armor stone at hinge.

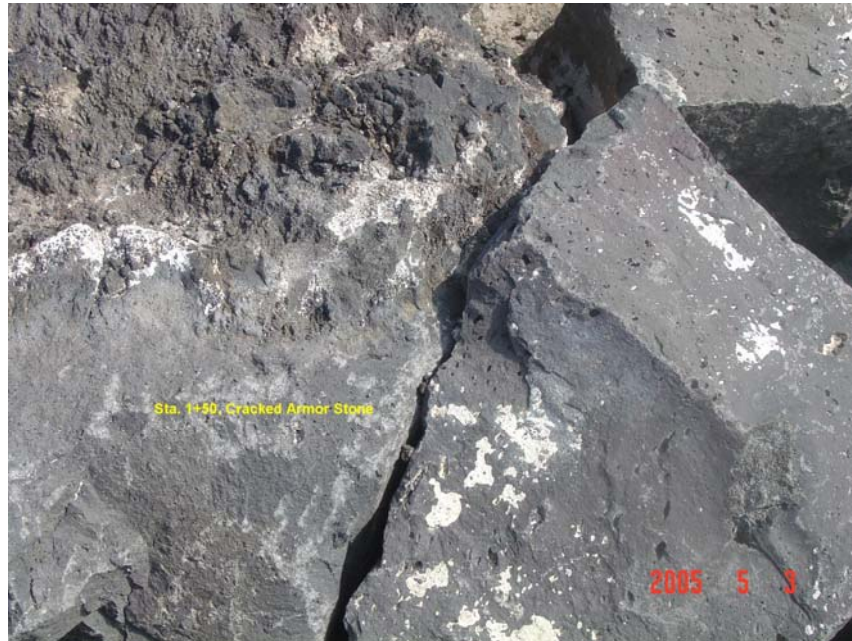
c. Sta. 1+50, CL, cracked armor stone, new this inspection.

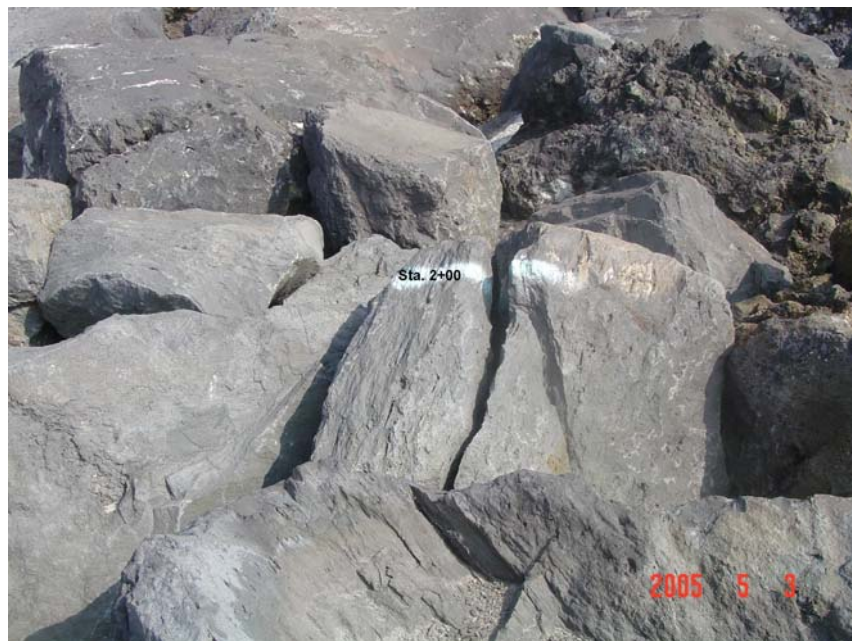
d. Sta. 2+00, OS, 2 ea. cracked armor stone.

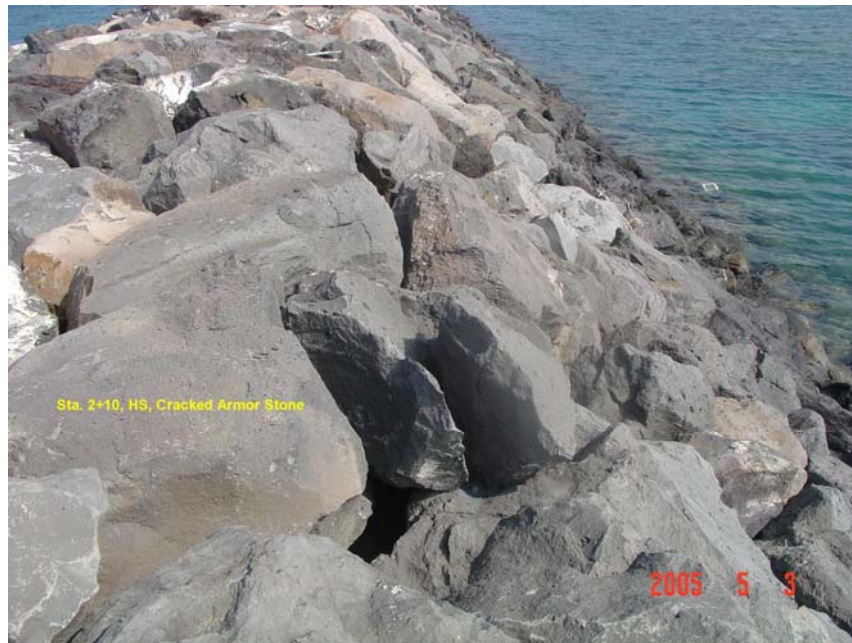
e. Sta. 2+10, HS, cracked armor stone @ hinge (adj. #3 dolphin).

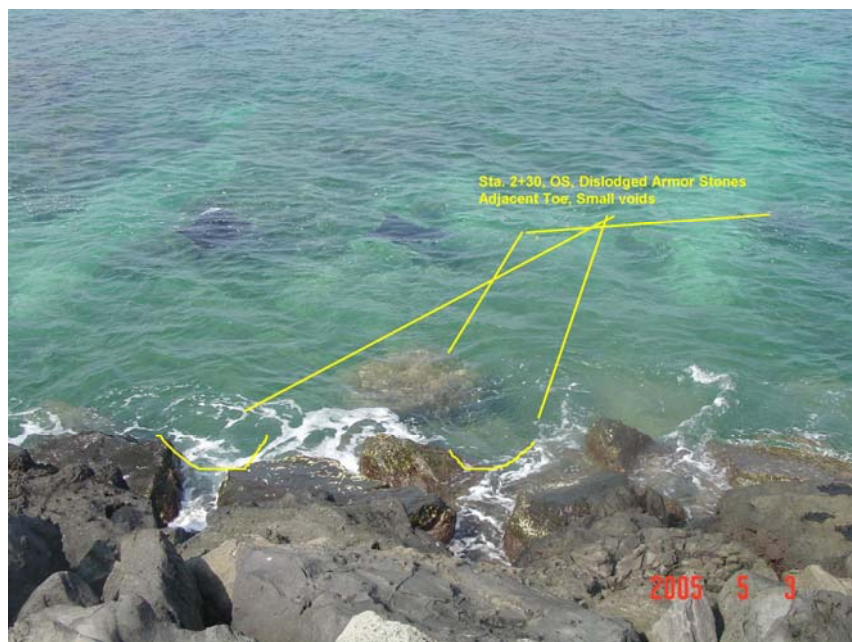
f. Sta. 2+30, OS, 6-8 ea. Armor stones dislodged from structure at waterline, now resting adjacent to the toe of the breakwater.

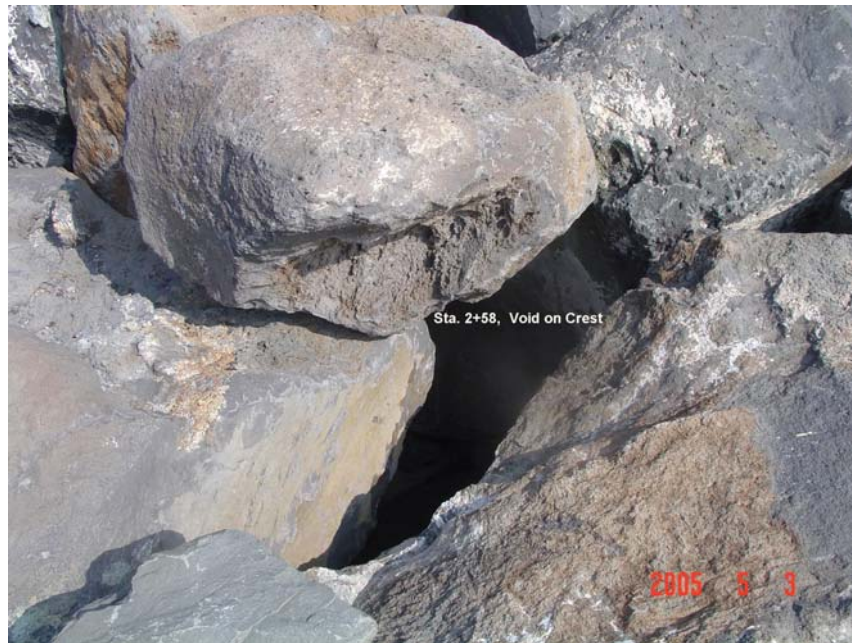
g. Sta. 2+58, void in crest.

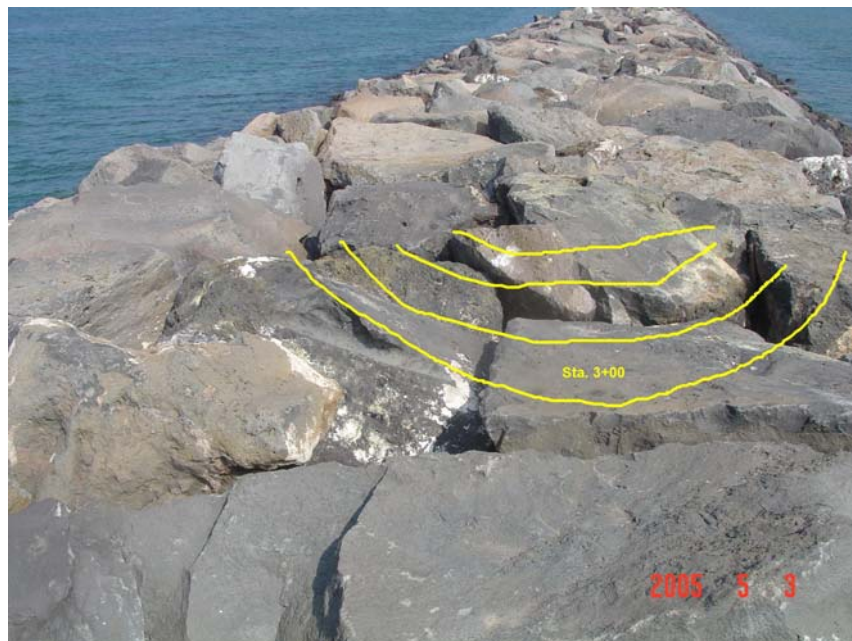
h. Sta. 3+00, CL, depressions extending along centerline.

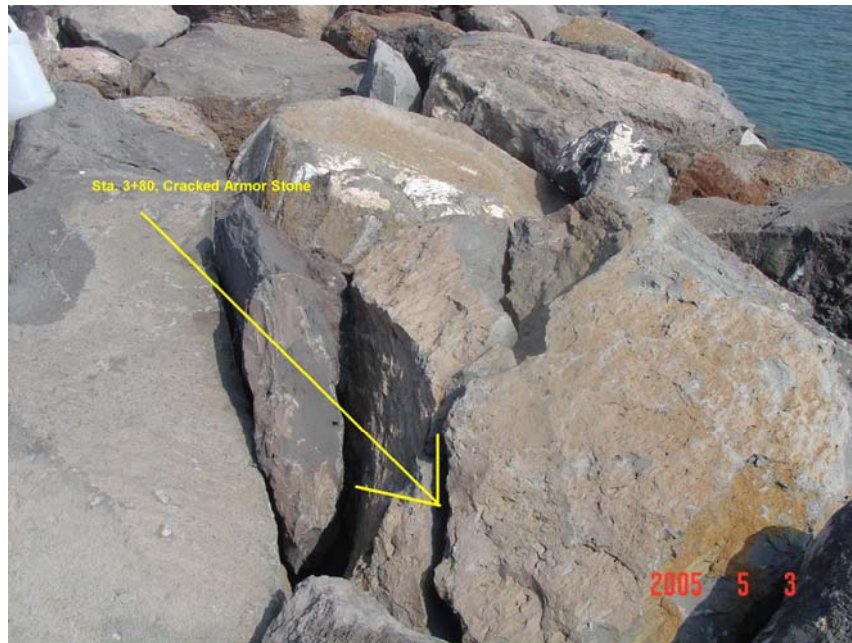
i. Sta. 3+80, CL, cracked armor stone.

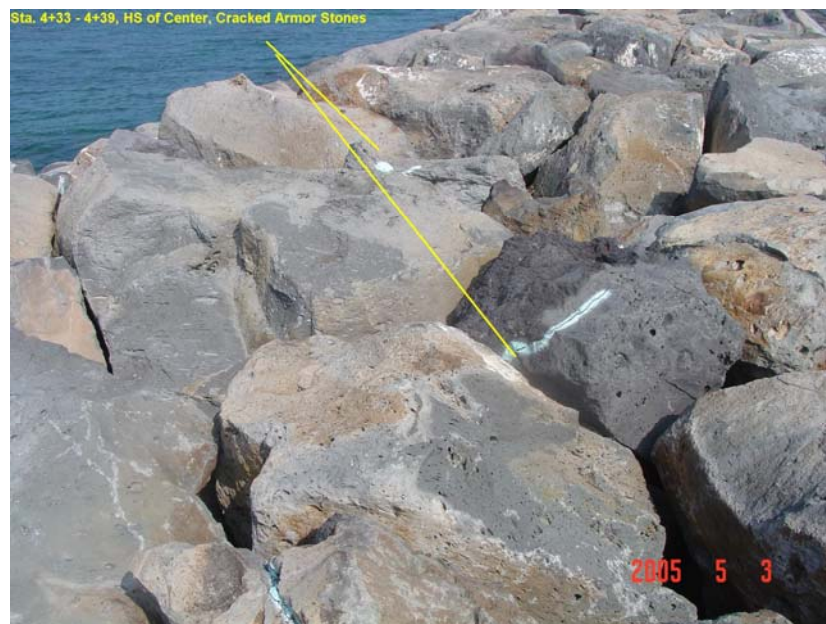
j. Sta. 4+33 to Sta. 4+39, CL, three cracked armor stones at crest. Settling of armor layer along crest and HS hinge. One flipped armor stone on OS.

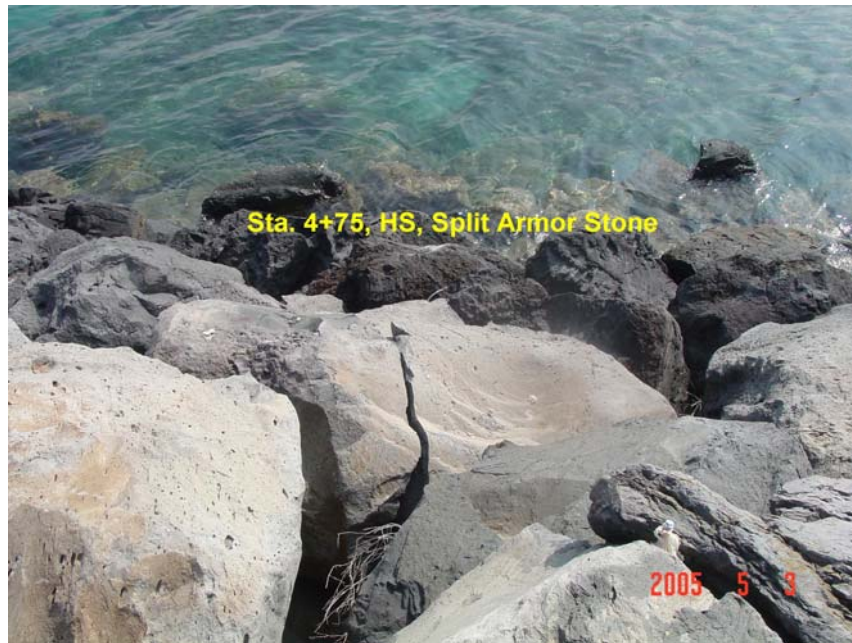
- k. Sta. 4+75, HS, cracked armor stone @ sideslope.

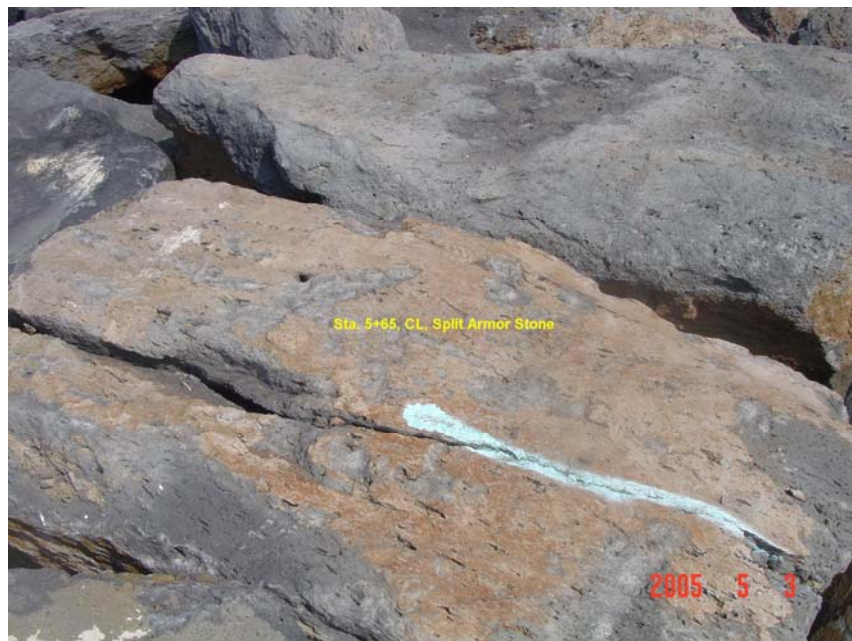
- l. Sta. 5+65, CL, cracked armor stone at crest.
- m. Sta. 6+00, OS, 2ea. dislodged armor stones resting 20 feet from toe, no obvious voids in sideslope. Unable to locate this year.

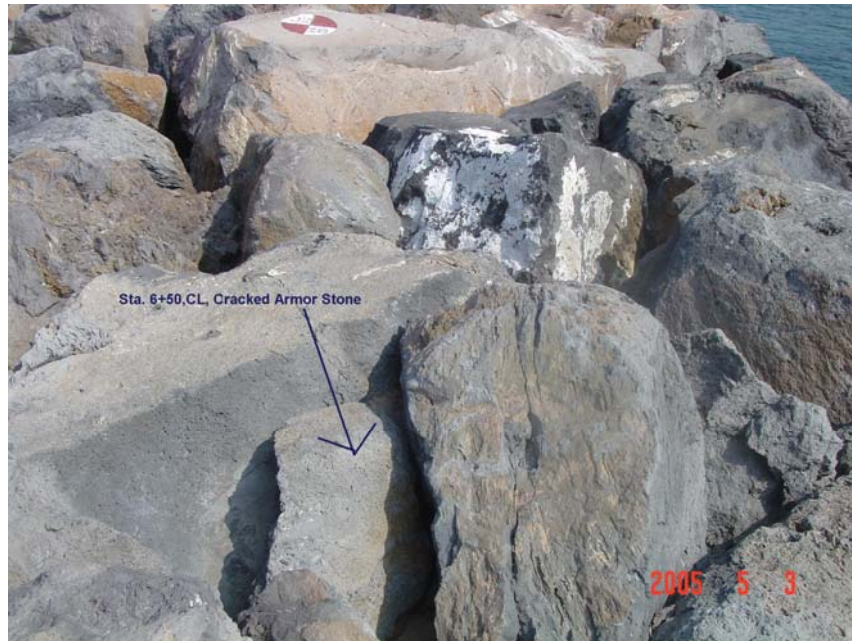
n. Sta. 6+50, cracked armor stone.

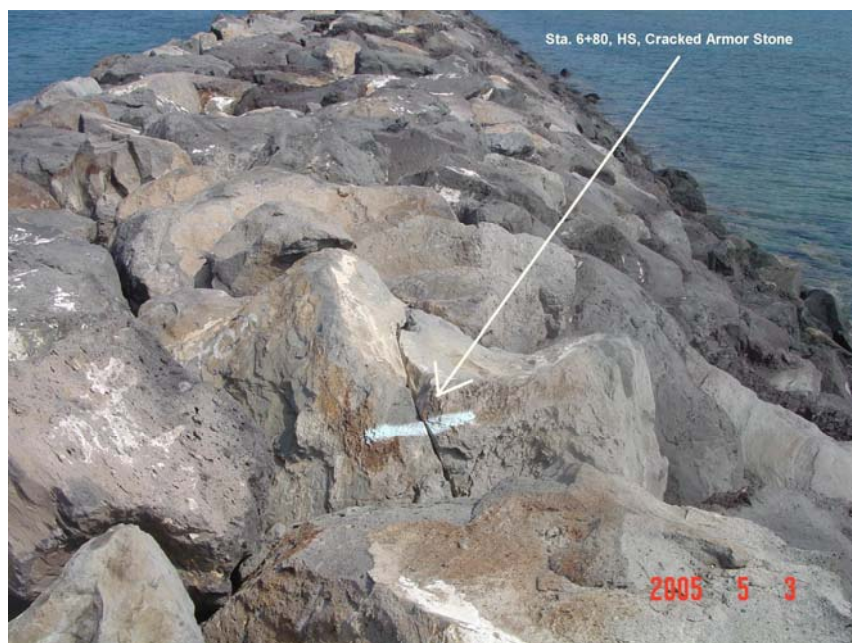
o. Sta. 6+80, HS, split armor stone on sideslope.

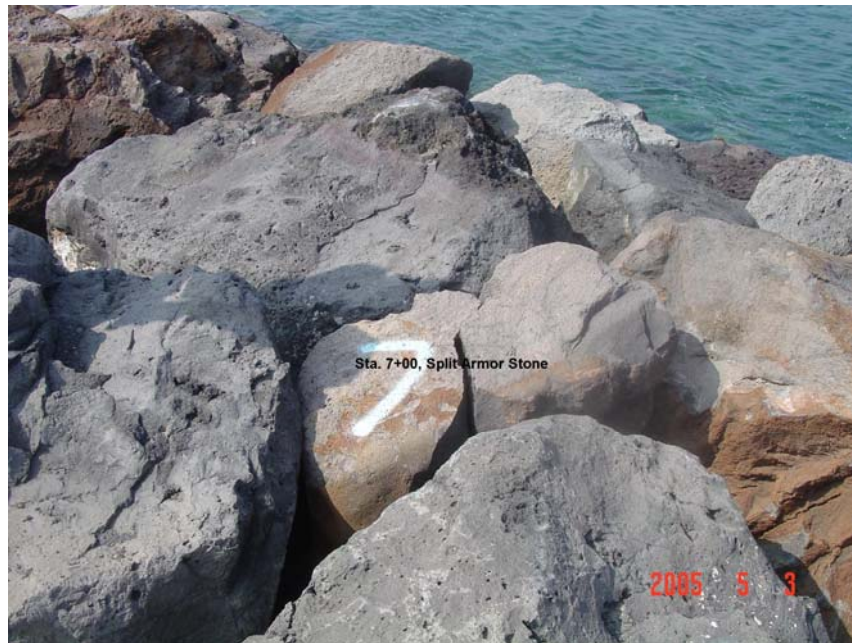
p. Sta. 7+00, split armor stone at hinge.

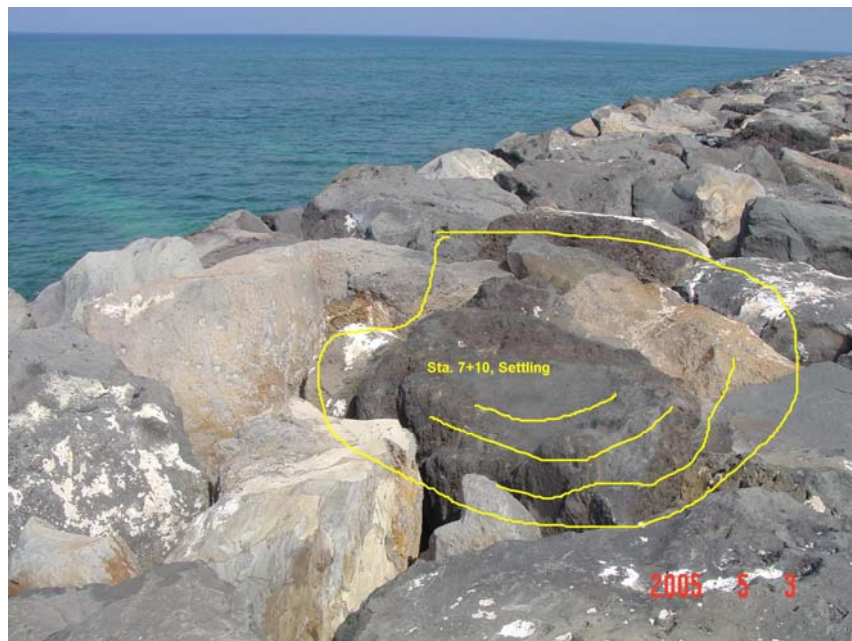
q. Sta. 7+10 to Sta. 7+20, settling at crest.

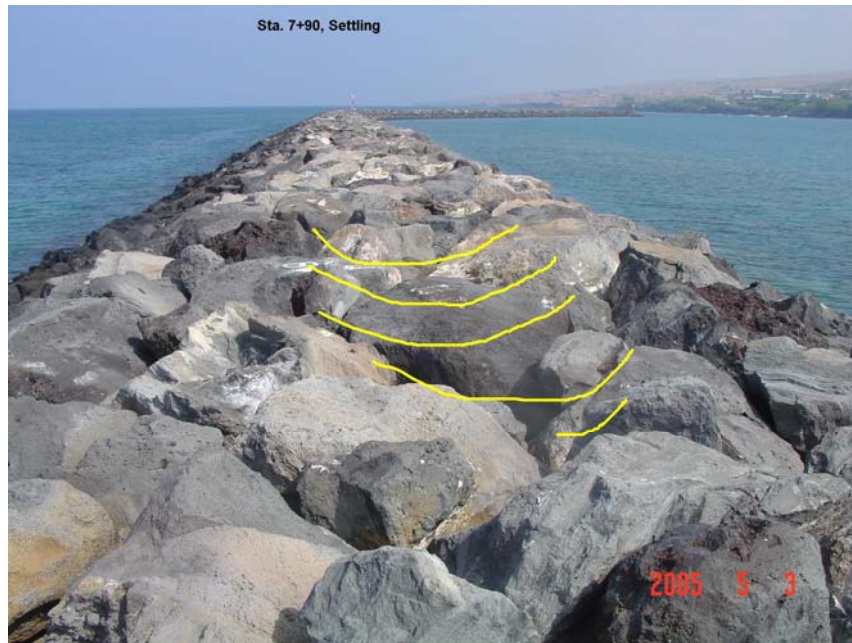
r. Sta. 7+90, CL, settlement.

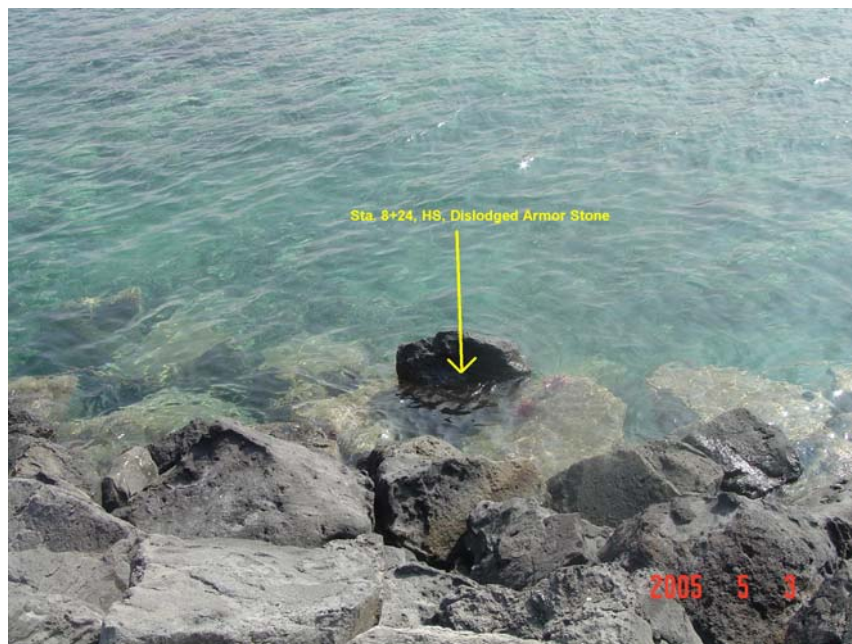
s. Sta. 8+24, HS, dislodge stone at toe, likely from sideslope.

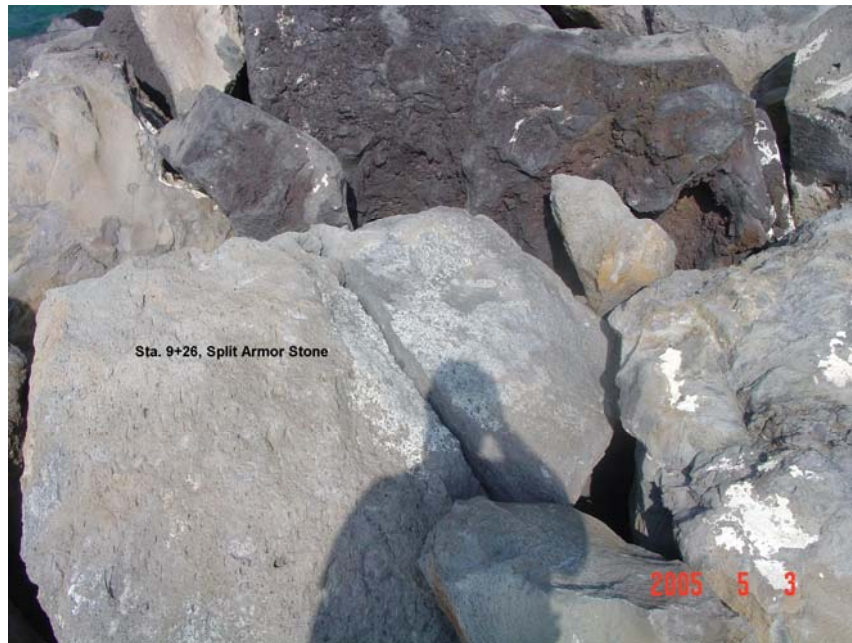
t. Sta. 9+26, CL, split armor stone.

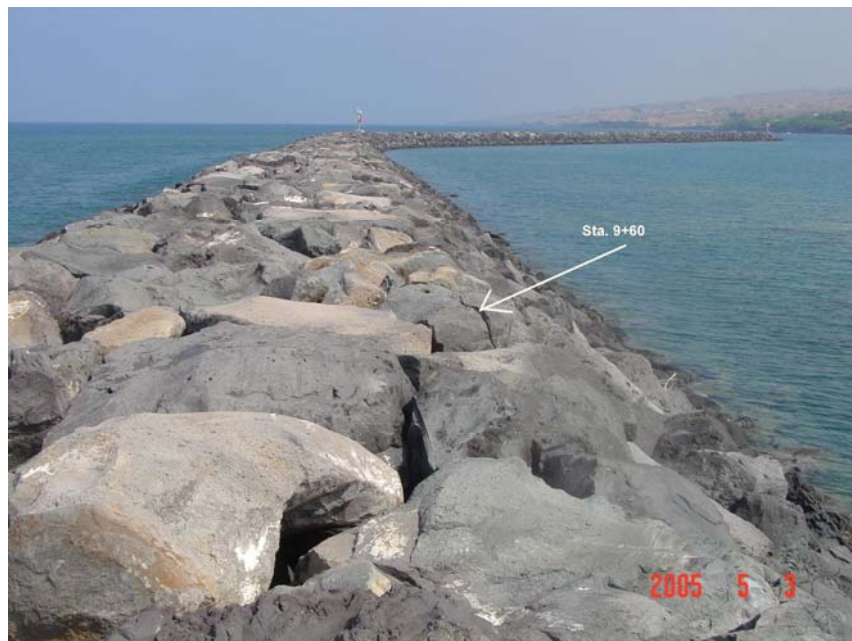
u. Sta. 9+60, HS, cracked armor stone at hinge.

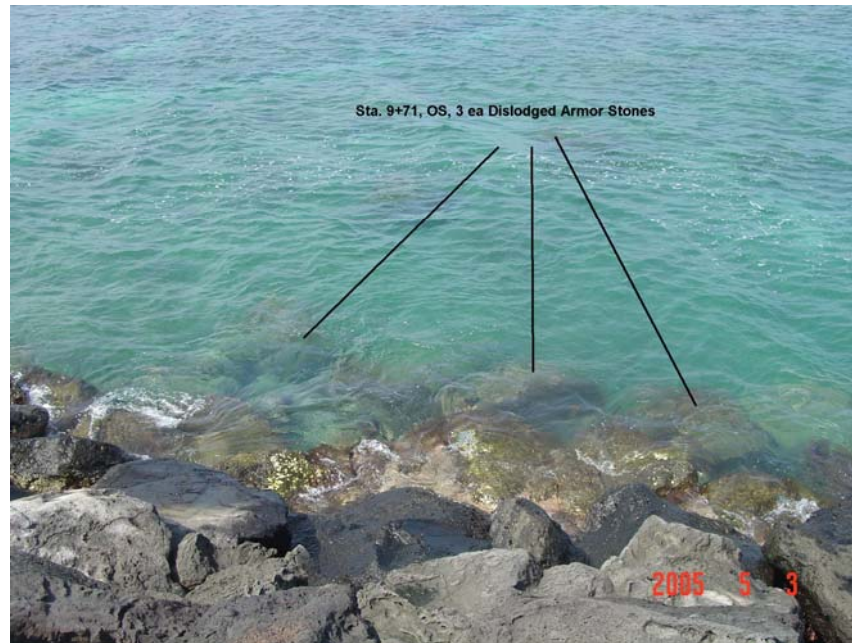
v. Sta. 9+71, OS, three armor stones have rolled off of the structure and into the water. Likely from structure sideslope at waterline.

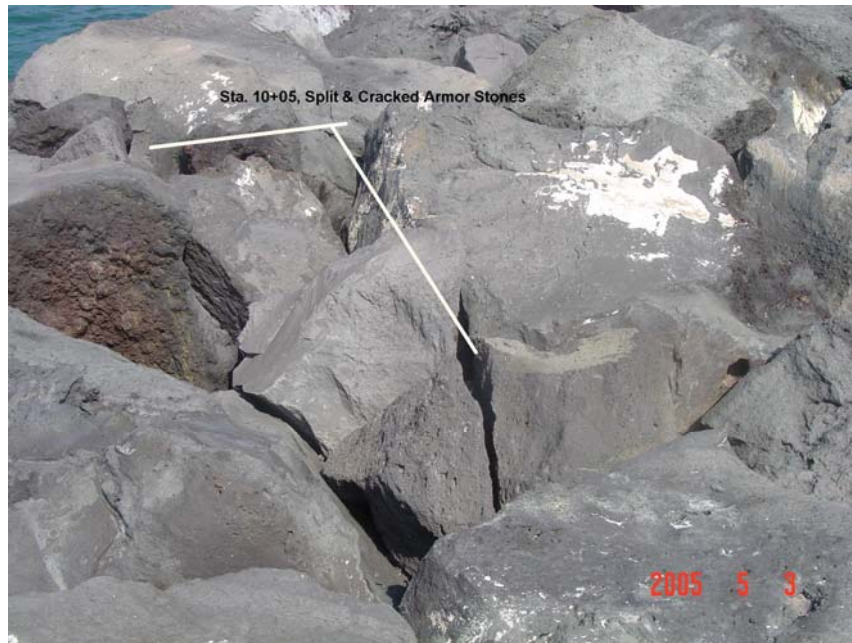
x. Sta. 10+05, CL, cracked / split armor stone.

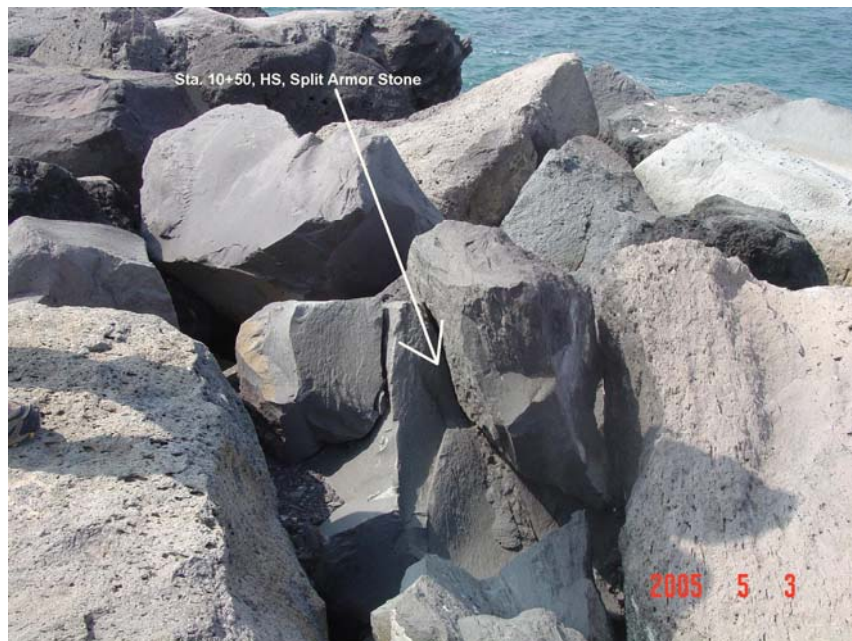
z. Sta. 10+50, HS, cracked armor stone.

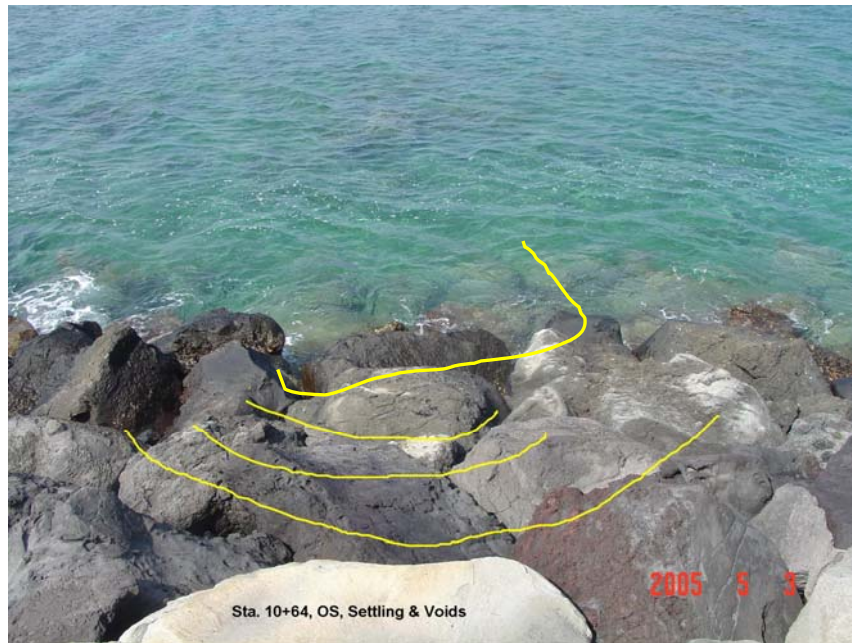
aa. Sta. 10+64, OS, voids at toe with some settling of structure above that point.

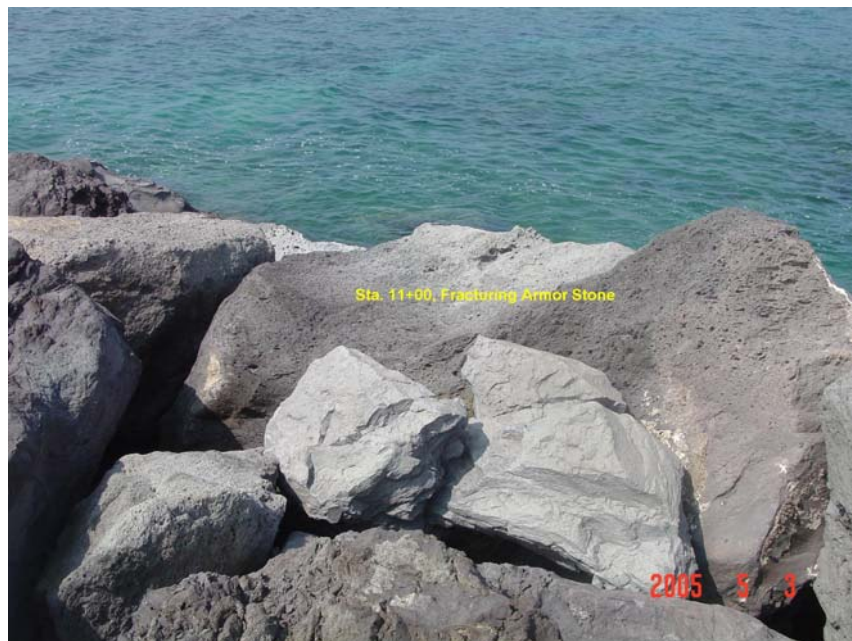
bb. Sta. 11+00, CL Crest, Fractured armor stone. Verify Station on next inspection.

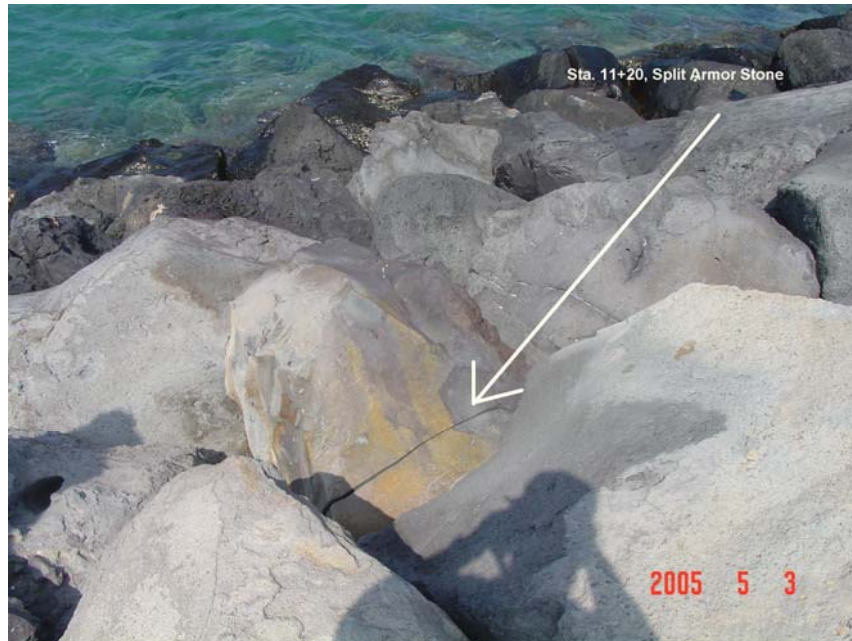
cc. Sta. 11+20, OS, split armor stone.

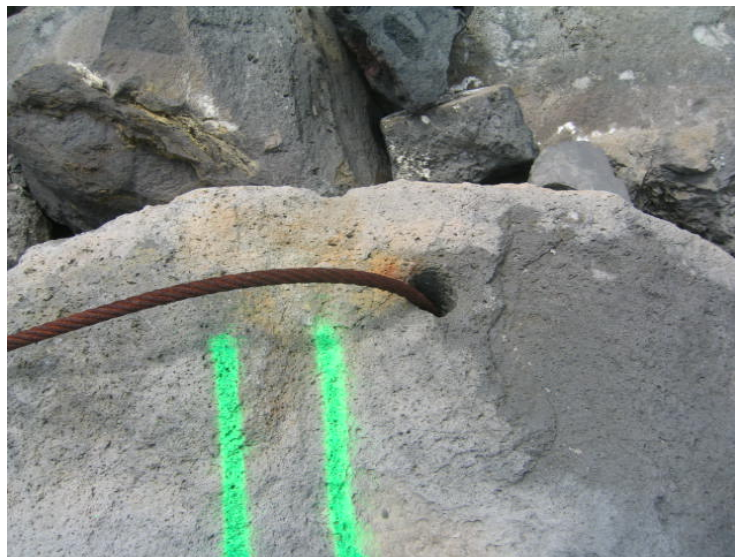
dd. Sta. 11+19, CL, wire rope thru armor stone.

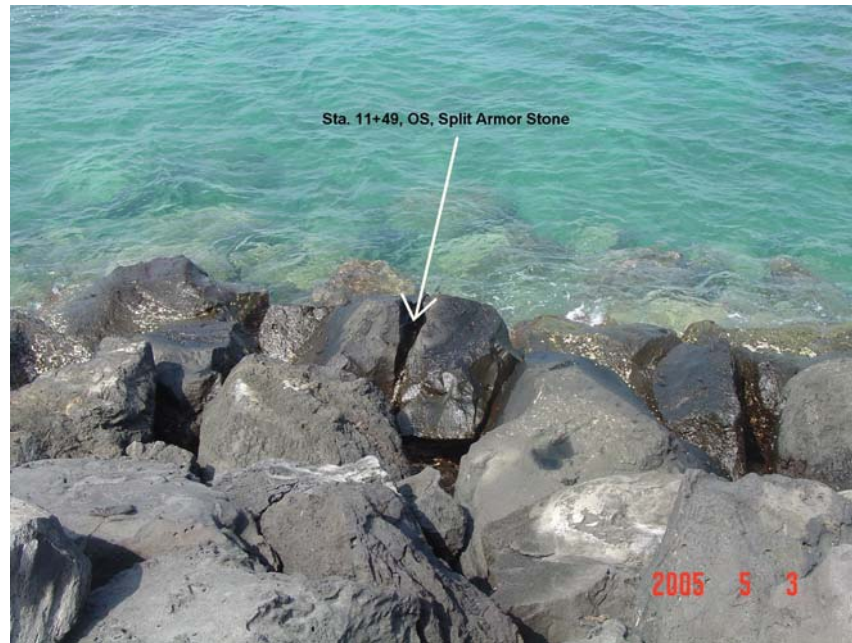
ee. Sta. 11+49, OS, 1 ea. split armor stone, no void.

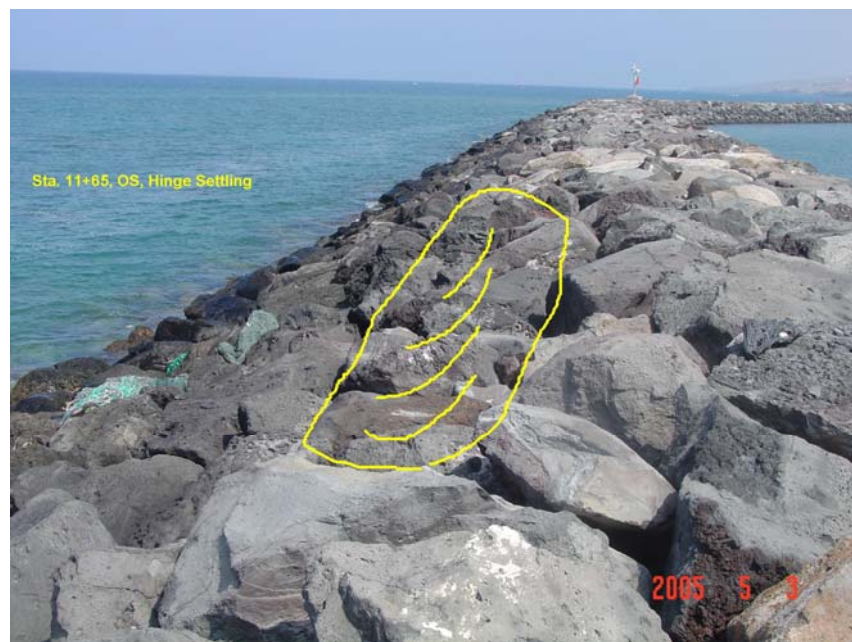
ff. Sta. 11+65, OS hinge, settling approx 20LF.

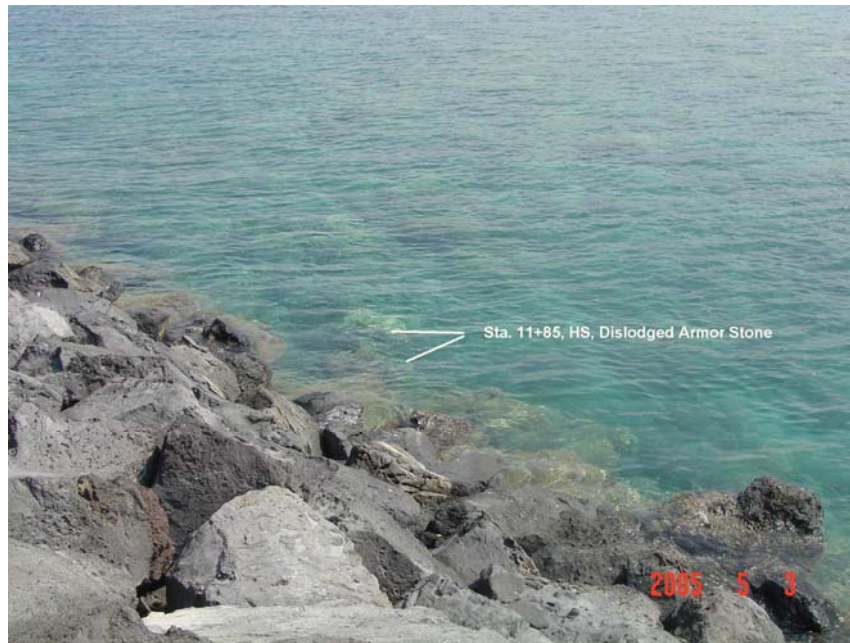
gg. Sta. 11+85, HS, Dislodged toe stones. No obvious voids.

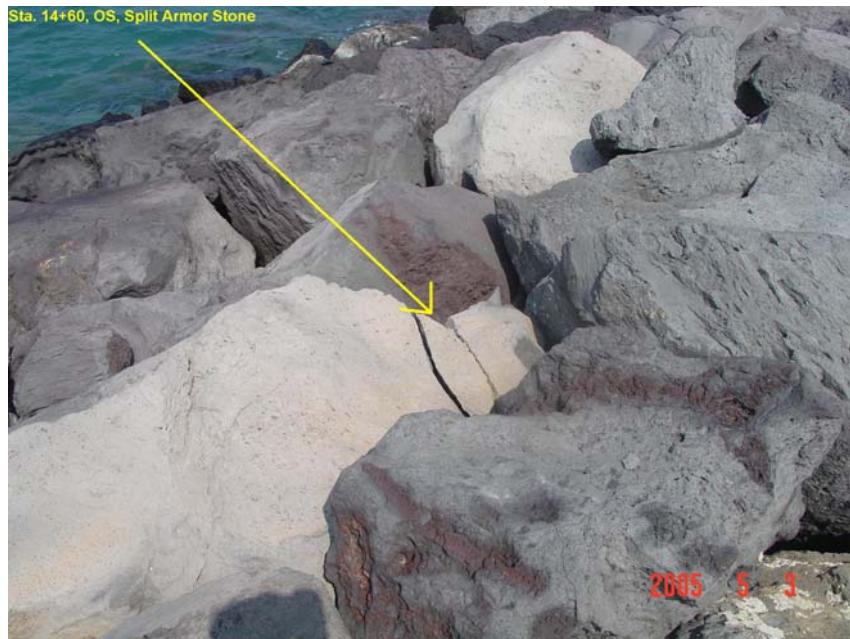
hh. Sta. 14+60, OS, Double split armor stone at hinge.

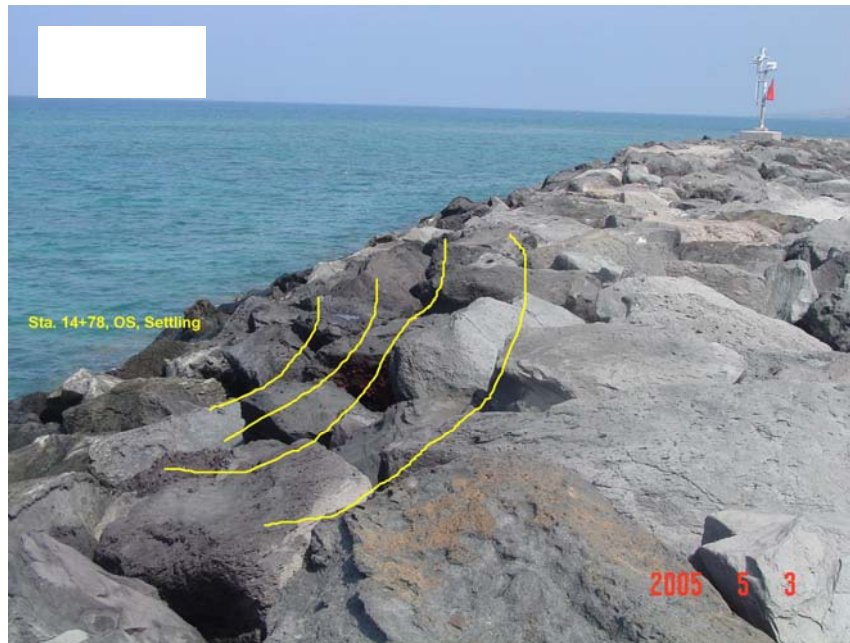
ii. Sta. 14+78 to Sta. 15+10, OS settling, approximately 20 feet of the sideslope beginning to extend into crest this inspection.

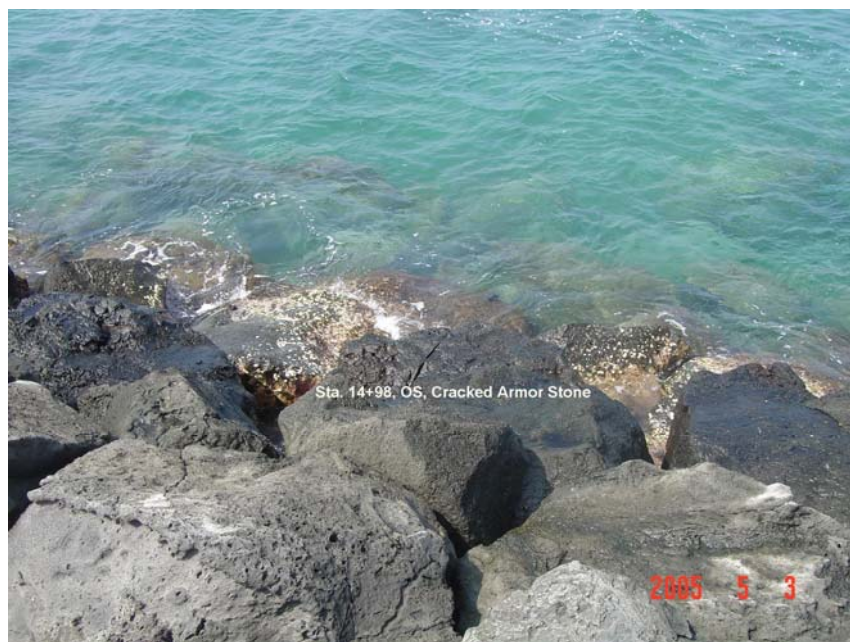
jj. Sta. 14+98, OS, cracked armor stone at waterline.

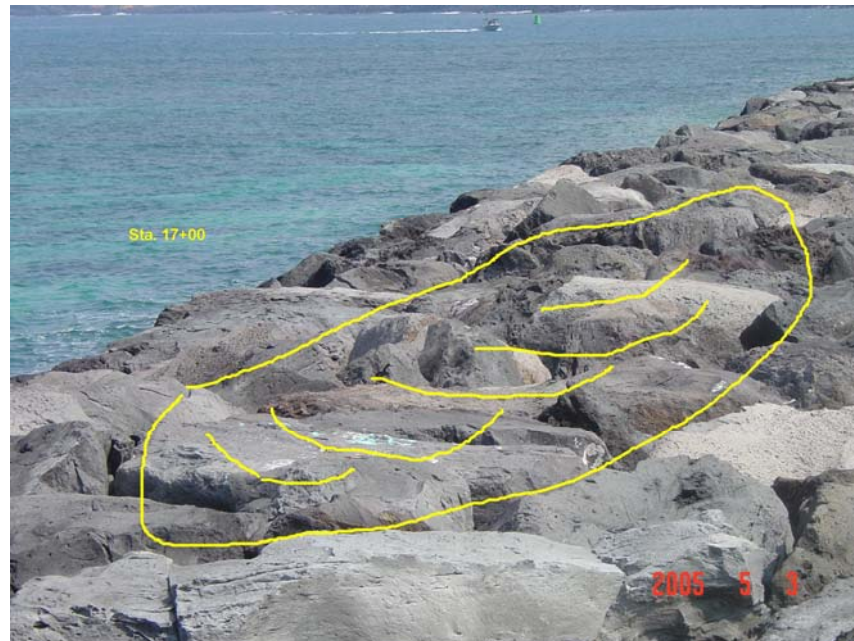
kk. Sta. 17+00, OS, settling along the sideslope / hinge.

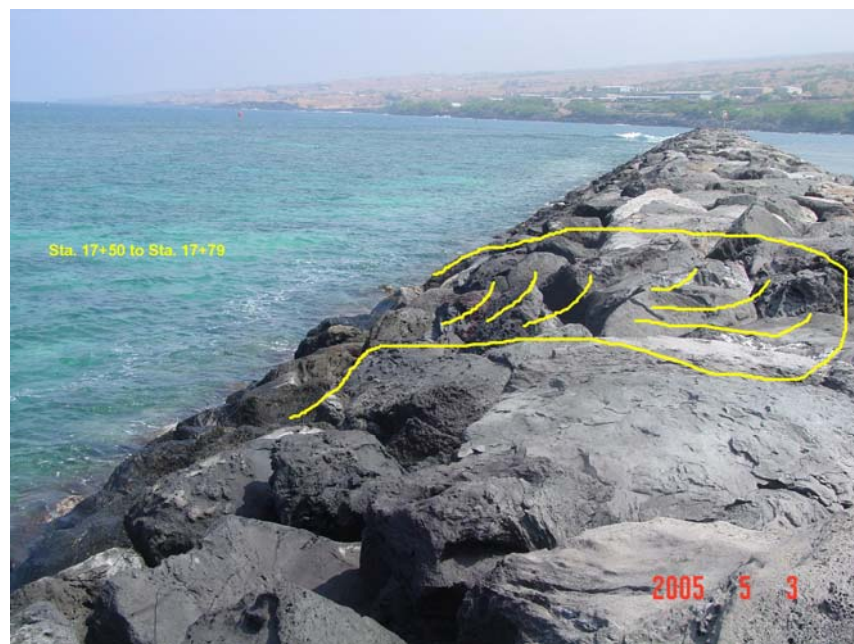
ll. Sta. 17+50 to Sta. 17+79, OS, sideslope and crest settling approximately 20 linear feet.

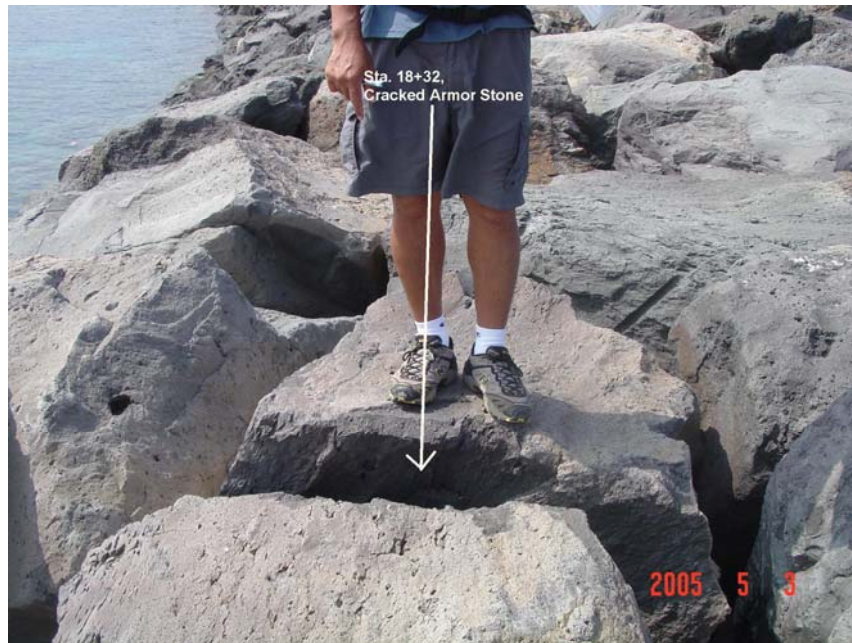
mm. Sta. 18+32, Crest, cracked armor stone.

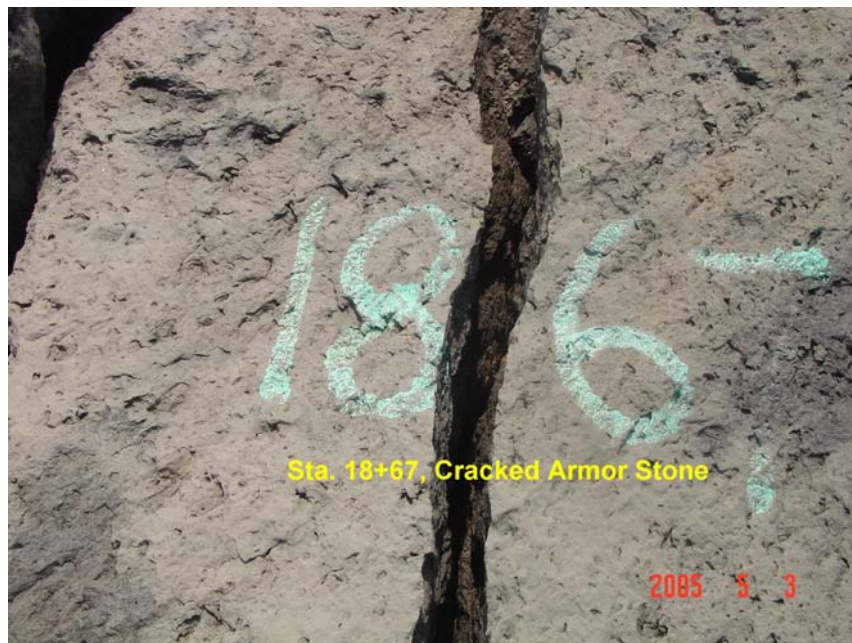
nn. Sta. 18+67, CL, cracked armor stone.

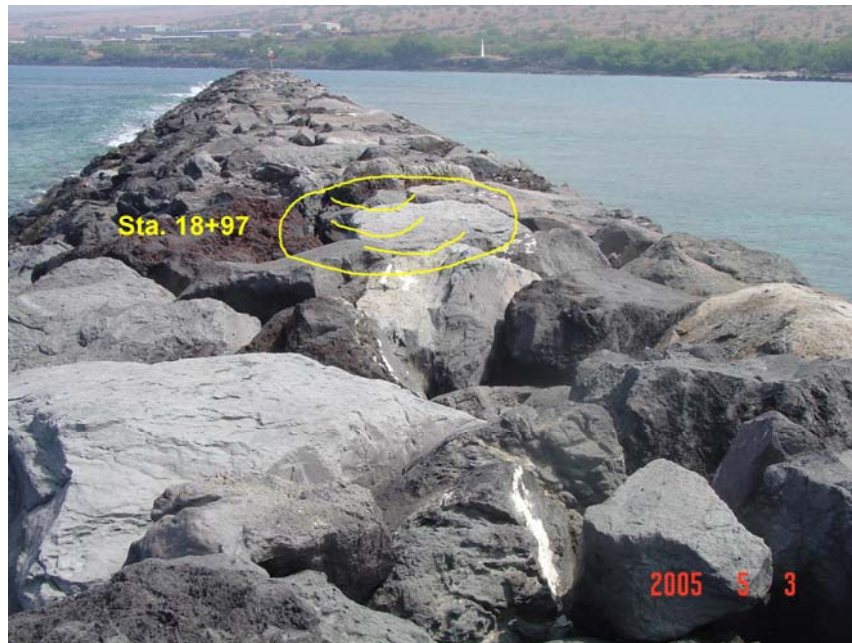
oo. Sta. 18+97, crest settling (3' x 3').

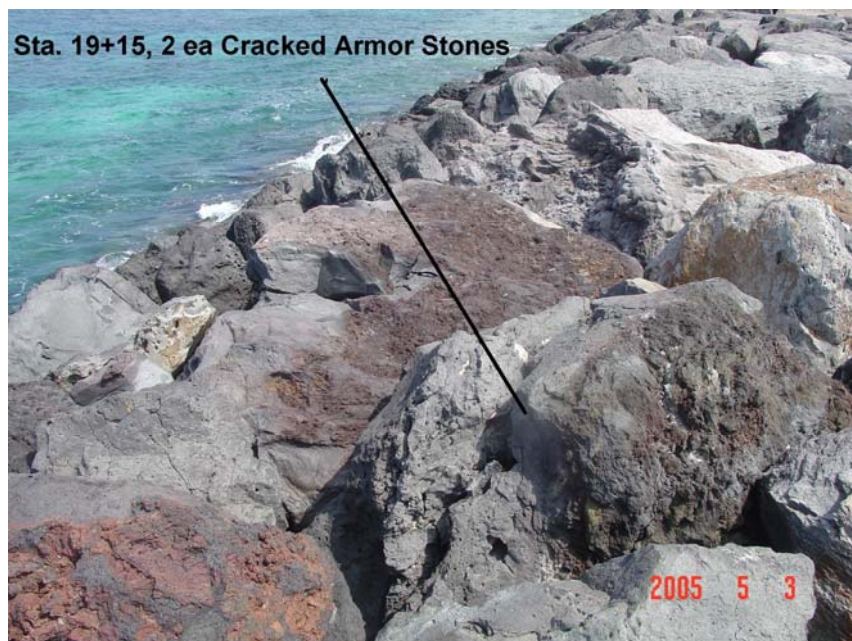
pp. Sta. 19+15, Crest, two cracked armor stone.

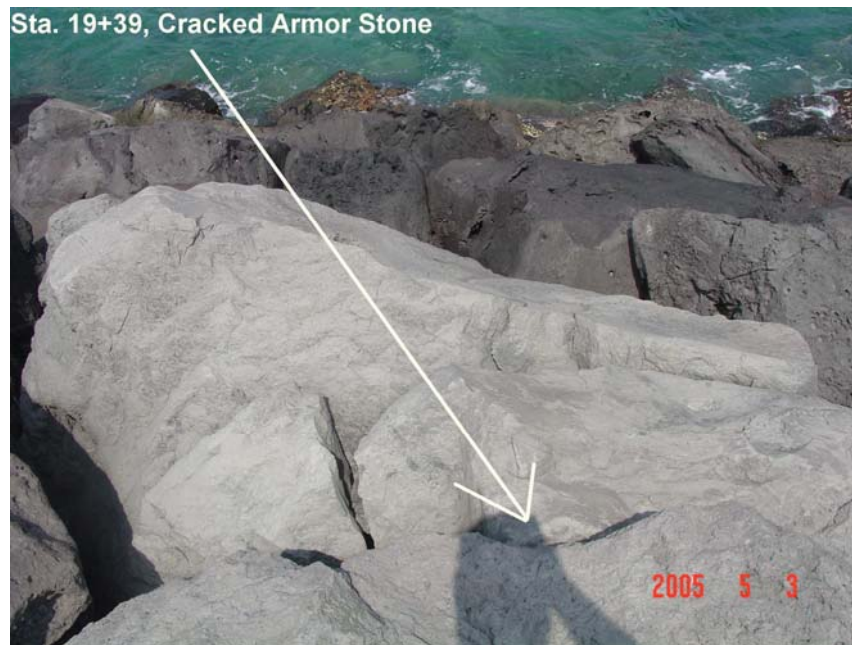
qq. Sta. 19+39, Crest, fractured armor stone.

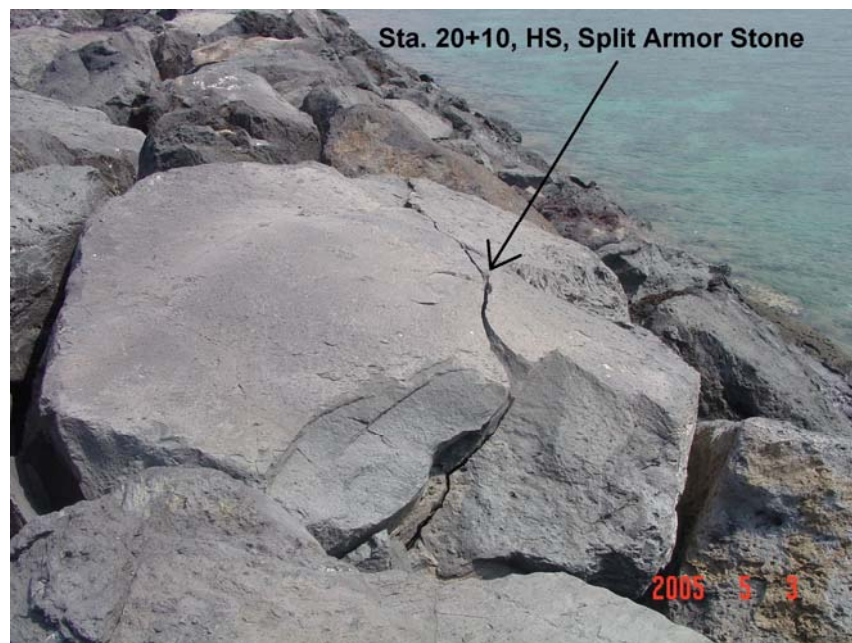
rr. Sta. 20+00, HS, three fractured armor stone (two OS and one HS).
